# Technical Memorandum 33-592

# *ATS-F Radiant Cooler Contamination Test in a Hydrazine Thruster Exhaust*

*Jose E. Chirivella*

**JET PROPULSION LABORATORY  
CALIFORNIA INSTITUTE OF TECHNOLOGY  
PASADENA, CALIFORNIA**

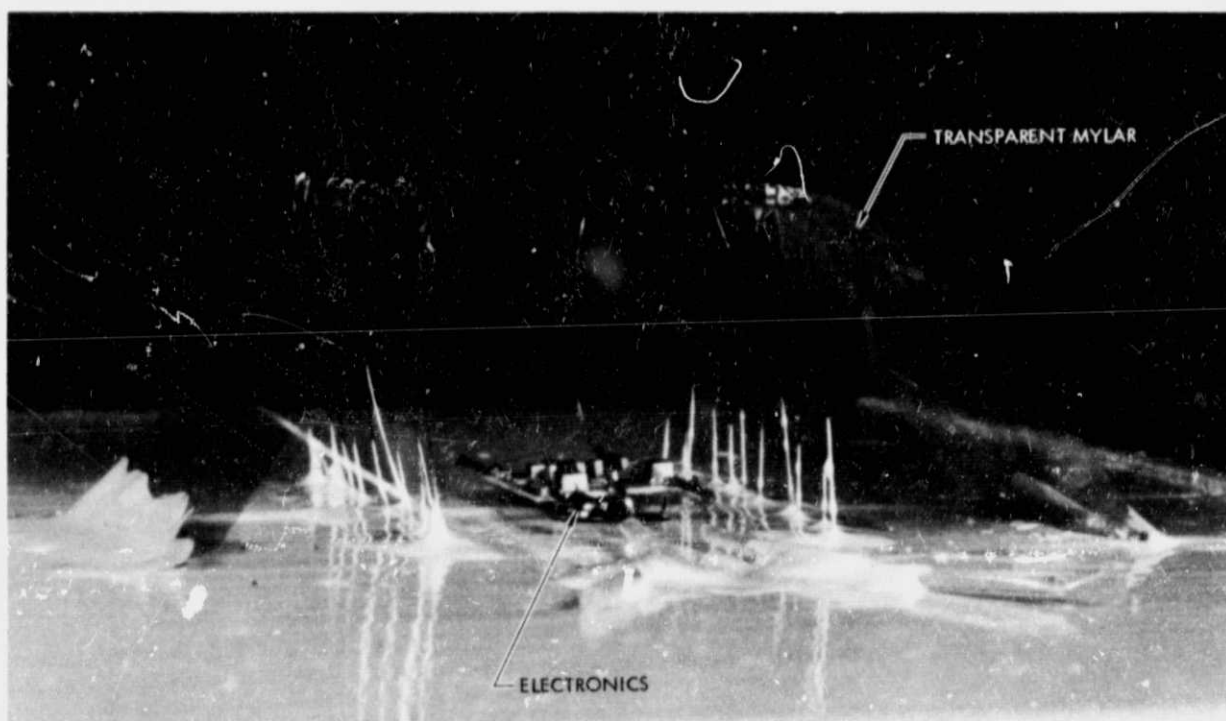
Fig. 17b. Photograph of a complete QCM mounted on the first-stage radiator surface

Details of the assembled unit without the wiring or mass shielding can be seen in Fig. 17a, where a unit is mounted on the mirror surface of the sun shield. The reflection on the mirror provides a view of the lower side. Another view of a different unit mounted on the first-stage radiator, along with a transparent Mylar mass shield and some wiring, is seen in Figs. 17b and 17c. Since the wiring is so extremely thin, the surface of the cooler is perturbed only slightly with this specific arrangement. The crystal locations and identifications in the cooler, as well as a general schematic diagram of the tested package, can be seen in Fig. 18. Three of the QCM units were mounted in the first-stage radiator, and three more in the inner side of the sun shield.
